Date: February 5, 2020

Subject: Outfall Sealing East End of Blocks D and F

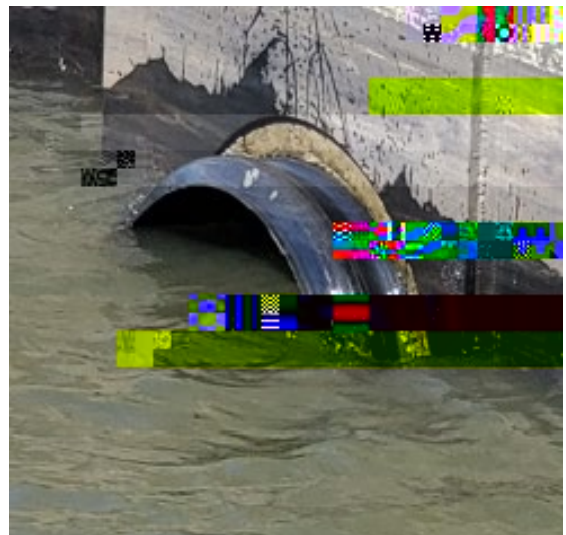
Observations of the outfall penetrations indicate that the concrete surrounding the corrugated HDPE pipe appears to be displaced and cracked. Probing in the cove adjacent these outlets indicates the presence of mounded granular soil that appears to be consistent with the volumes of material lost surrounding the culvert. Inspection of the invert of the pipes is not possible, since they are partially submerged, but it appears likely that the conditions observed for the exposed portions are representative of the full circumference of the pipe.

Based on these observations, it appears that tidal action is flushing granular fill through openings around the circumference of the pipes at the two outfalls. The openings appear to be the result of fracturing and displacement of the concrete where it adjoins the steel wall components. Because the area over the pipes consists of concrete cast to the sloping granular fill surface, the concrete is in a trapezoidal shape and the granular fill loss is occurring in an hour-glass fashion concentrated along the contact between the granular fill and the concrete. This results in the surface expression appearing as a sinkhole several feet off the centerline of each pipe.

Figure 1 - Recess in anular concrete at OF-00X

The mechanical seal option would be expected to be much higher to include design and fabrication of the plates, support vessels, divers, lifting equipment, etc. The cost would be expected to be in the range of \$15,000 to \$20,000.
