February 5, 2018

## Subject:2017 Monitoring of Dredge Area D2-6 for Sediment DepositionMiddle River Complex, Middle River, Maryland

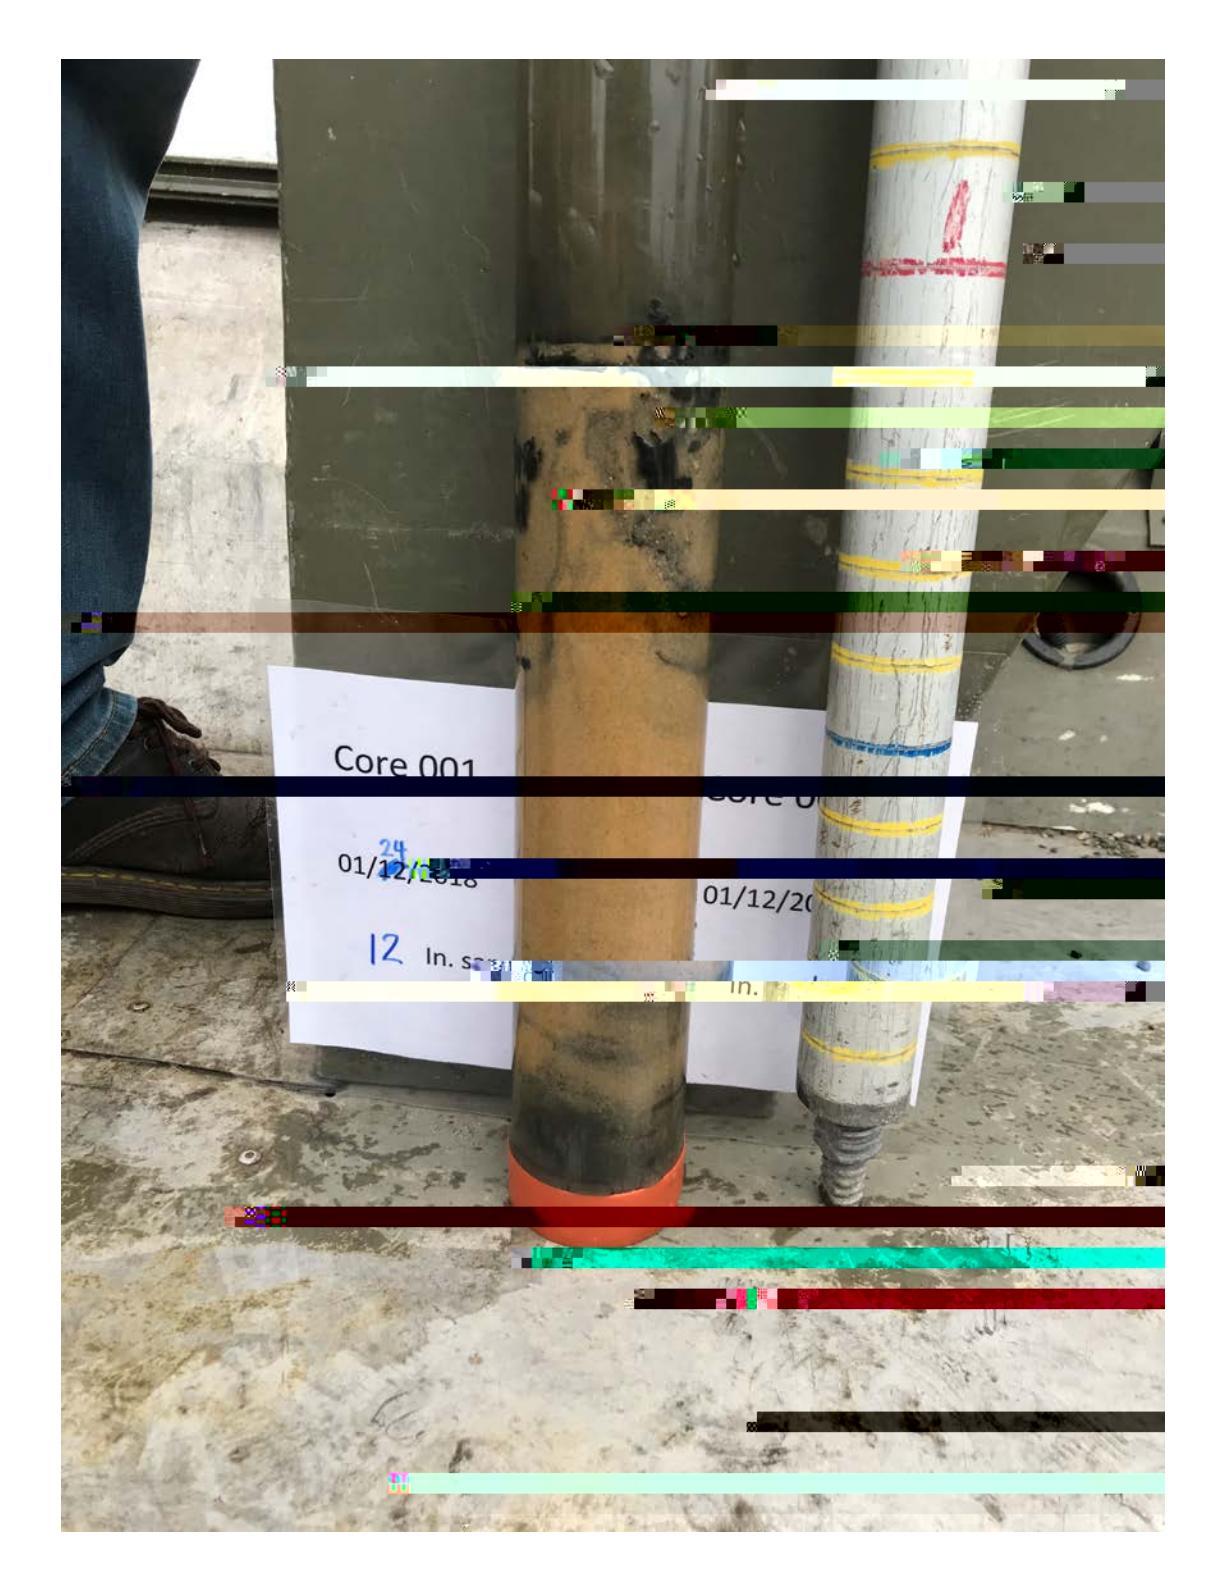
Figure 2. Sediment core from January 2018 DMU D2-6 sampling location #1.

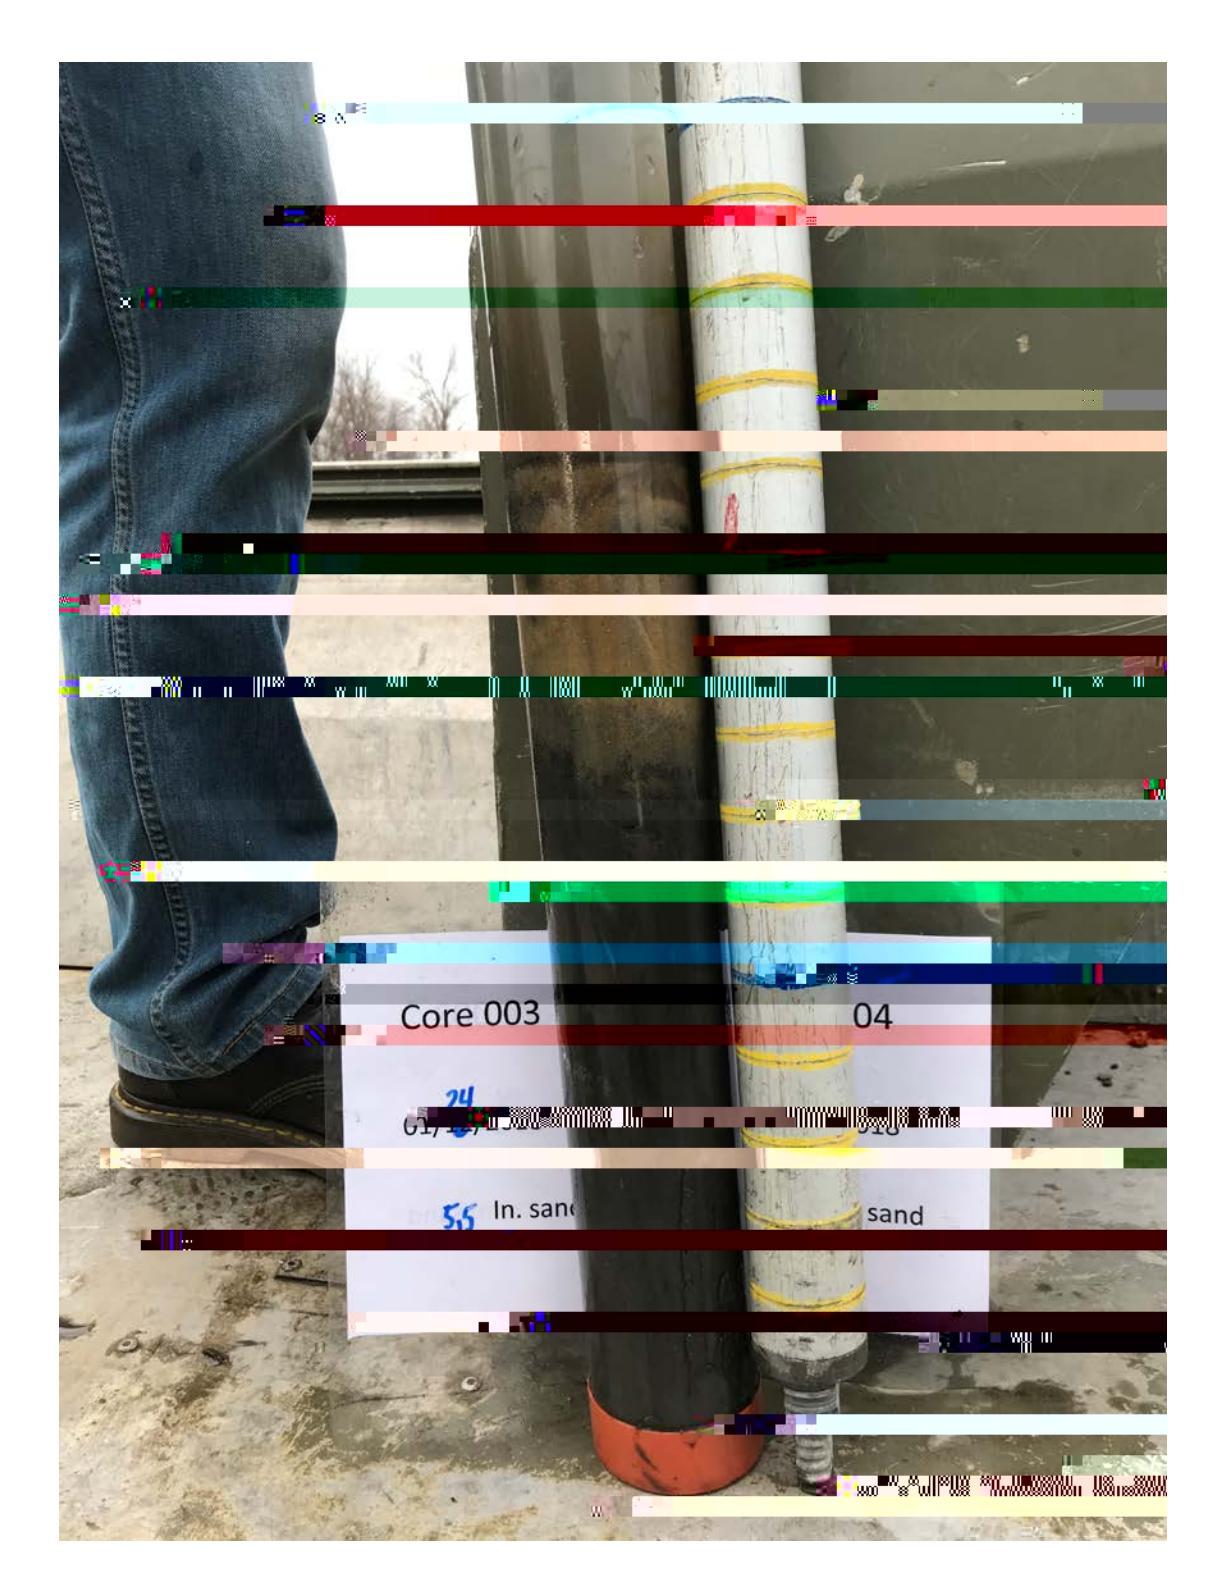
Figure 3. Sediment core from January 2018 DMU D2-6 sampling location #2.

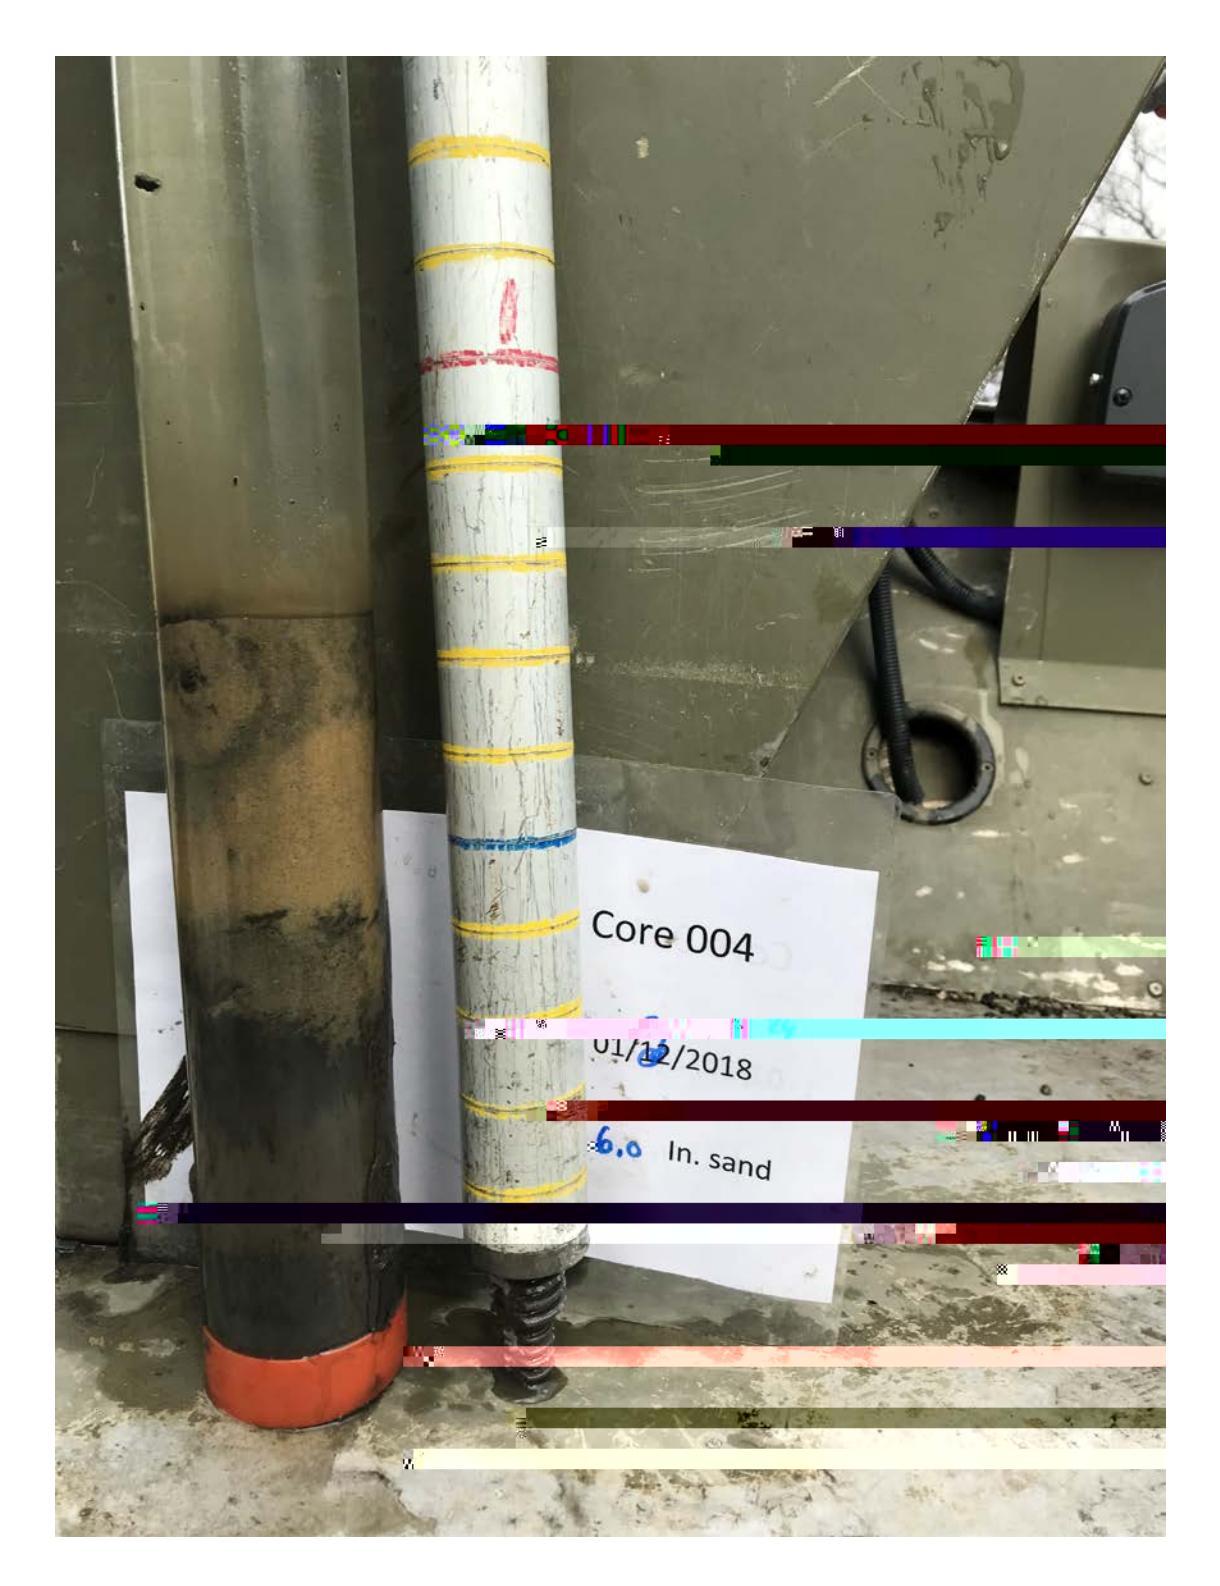
Figure 4. Sediment core from January 2018 DMU D2-6 sampling location #3.
